PRIDE & JOY

No Worries

When fire swept through Mike Turner's Aquanaut 36 at her marina berth, the occupants were lucky to escape unhurt. The boat, however, was a complete write-off. Or was it?

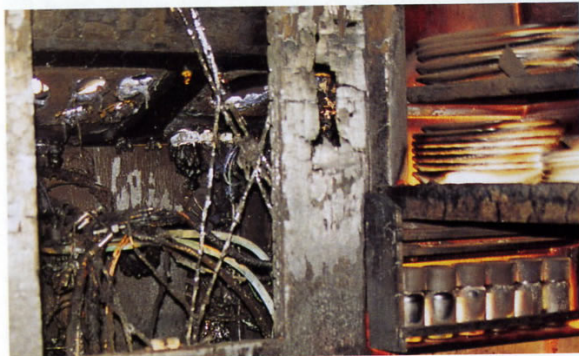
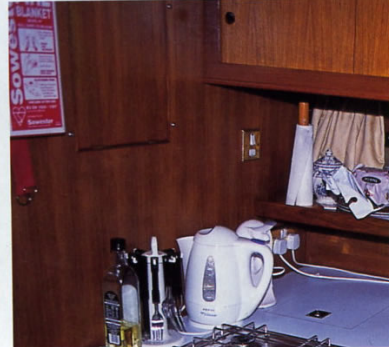
Above left opening this panel to trace the source of the smoke, fed the fire and caused an explosion. *Above right* the panel in the restored galley, minus the spice rack.

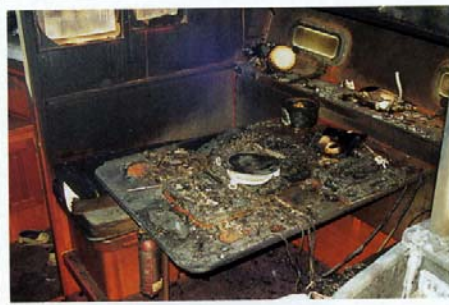
The fire extinguisher near the start of the blaze was the only one not used.

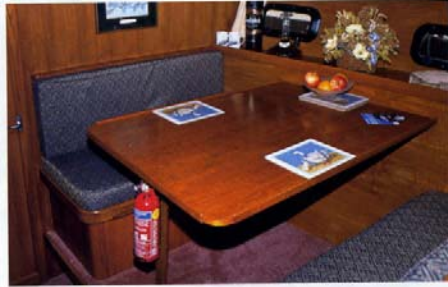
Fully restored, the area opposite the galley also forms a double berth.

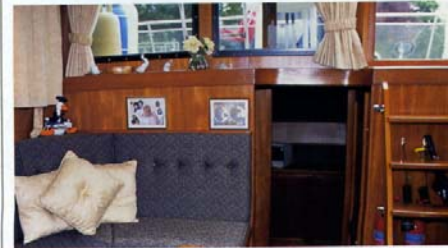
Mike's wife chose a new colour scheme for the upholstery and curtains.

Mike's wife Kathy had some clear ideas about how she wanted the interior furnishings to look. She chose a new colour scheme for the fabrics, curtains and carpets, and insisted that an existing shelf in the saloon was replaced exactly as it had been previously. The dimensions were perfect to house her beloved Lladro collection of Spanish pottery.

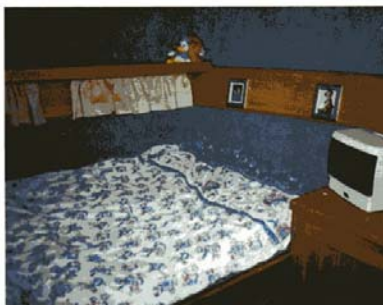
The original joinery has been faithfully recreated.

The final touch was to varnish all the woodwork to the original specification. "How Bruce the shipwright achieved what he did with the teak joinery, I do not know," Mike says.

"Just by studying the charred remains of the cupboard doors in the aft cabin, he managed to recreate perfectly all the other doors throughout the boat as originally installed. In my opinion, he performed a miracle."

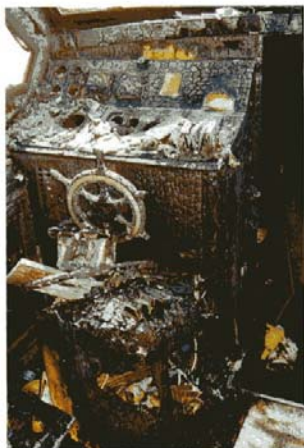
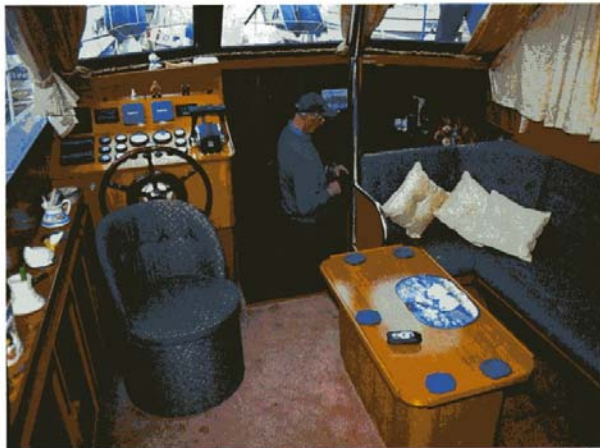
"The interior helm position was charred almost beyond recognition, the galley totally destroyed, and the saloon windows were all gone. There was also a lot of damage to the bridge-deck immediately above the saloon. Although most of it was confined to the port side of the boat, the smell of burnt wood and fabric was overpowering."

Above left charred almost beyond recognition, the helm station took the brunt of the blaze. Above right the rebuilt saloon, slightly modified by extending the seating.

Mike had always wanted to improve the galley as he was unhappy with its design and this was an excellent opportunity to make some changes. The galley units were moved to give more space, the fridge was relocated, and the seating in the saloon area extended. Because these changes were asked for early in the refit, GYS were able to incorporate them at no extra cost.

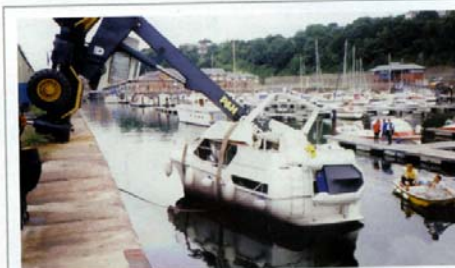
Above when a lift-out went wrong, the crane toppled over and impaled this Carver. The damage was extensive, but was 'invisibly mended' by GYS.
